FCM 035-2016

FIRE CHIEF MEMORANDUM

SUBJECT: **AFTER ACTION REVIEW-Engine 24 FF INJURY, Incident 16-21551**

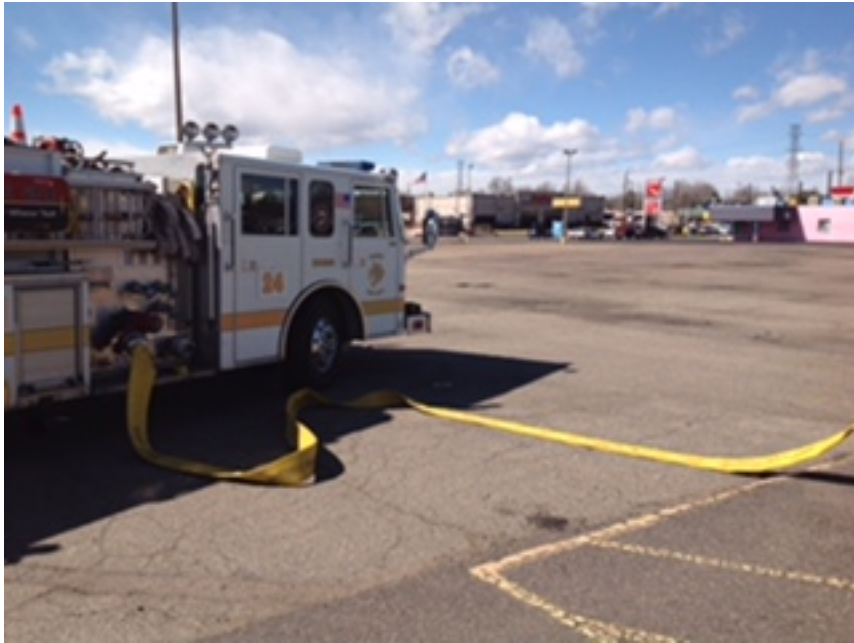
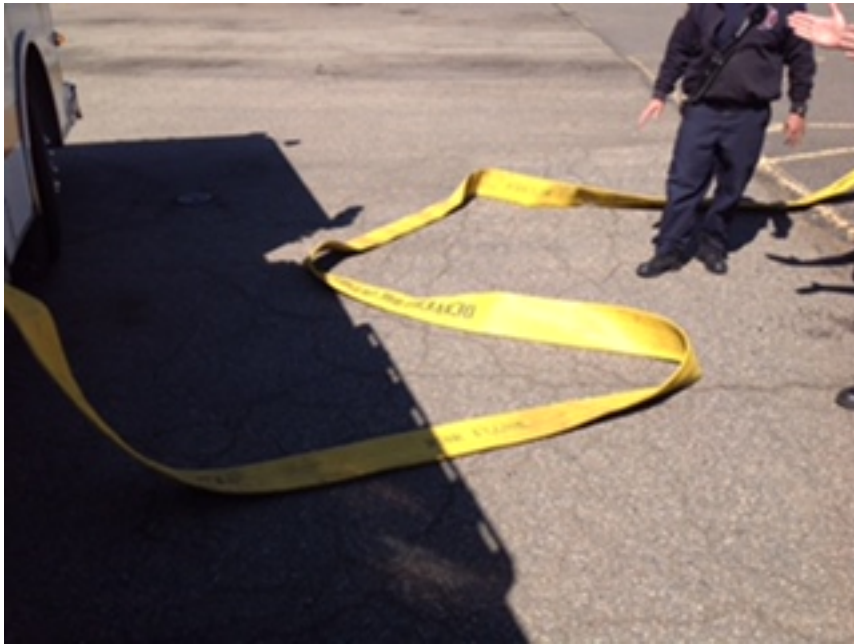
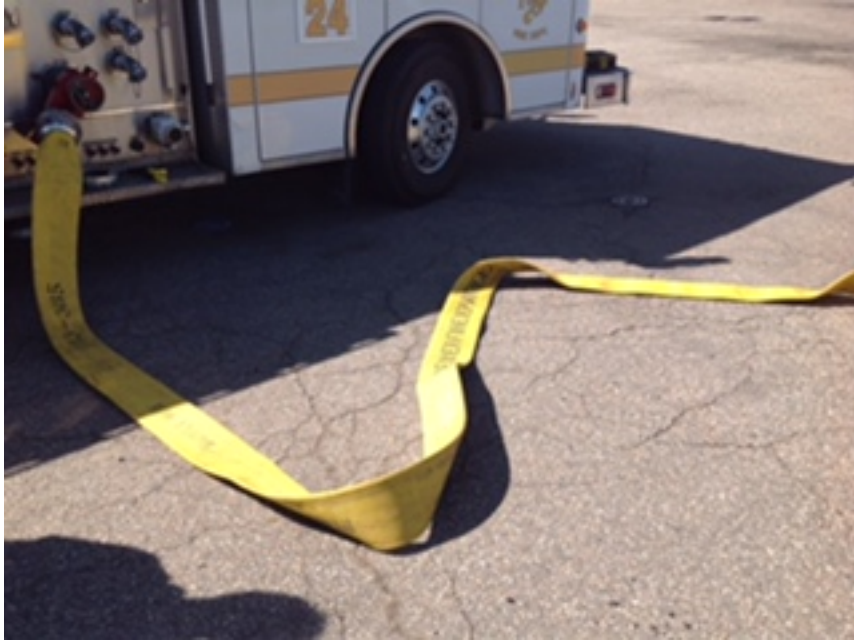
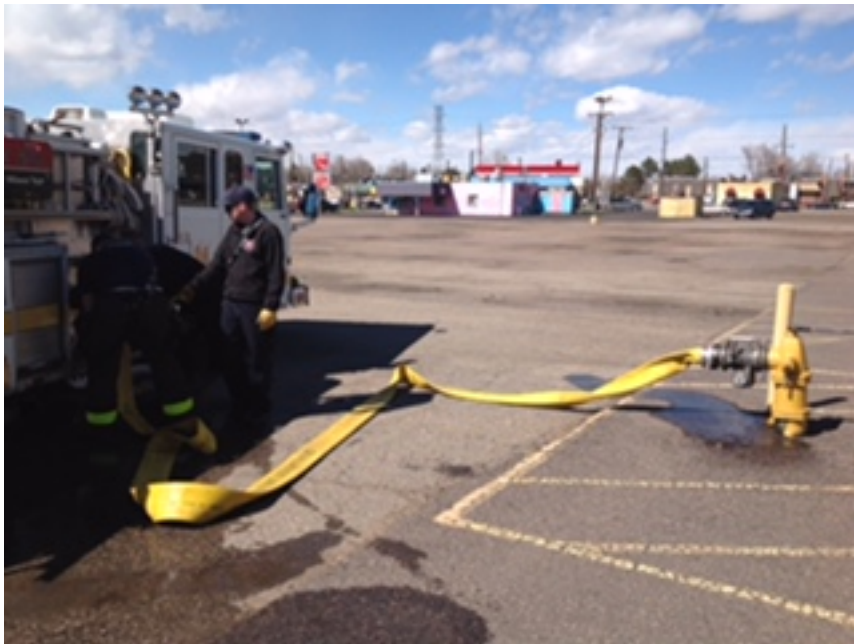
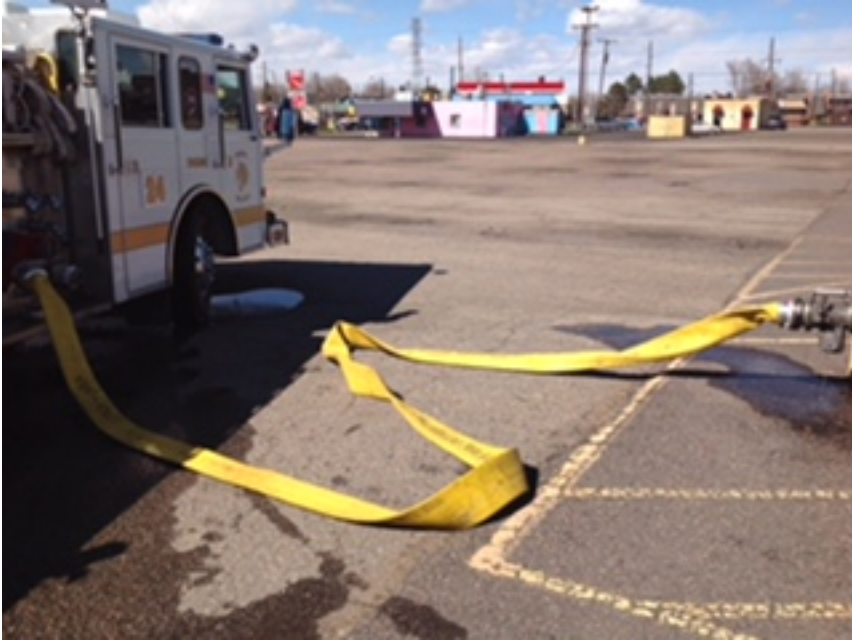
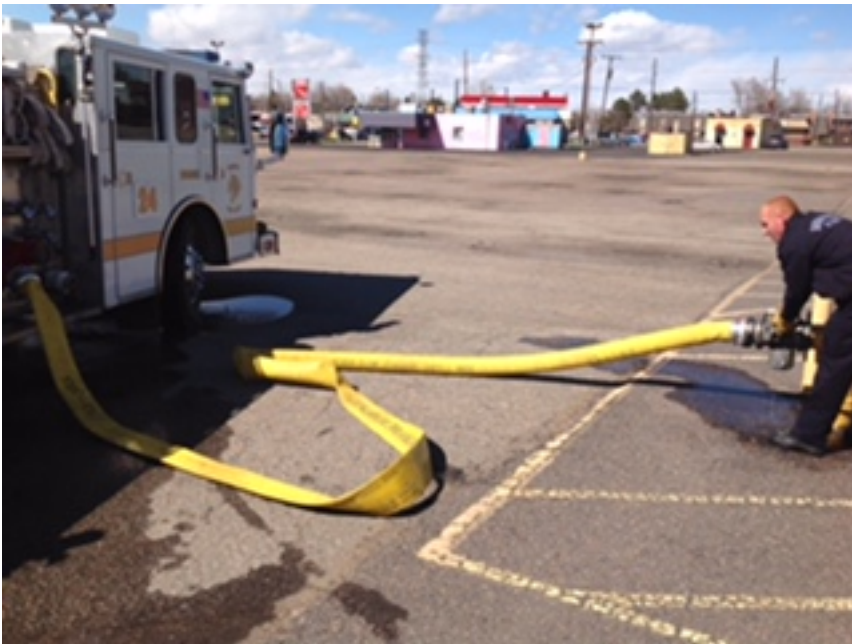
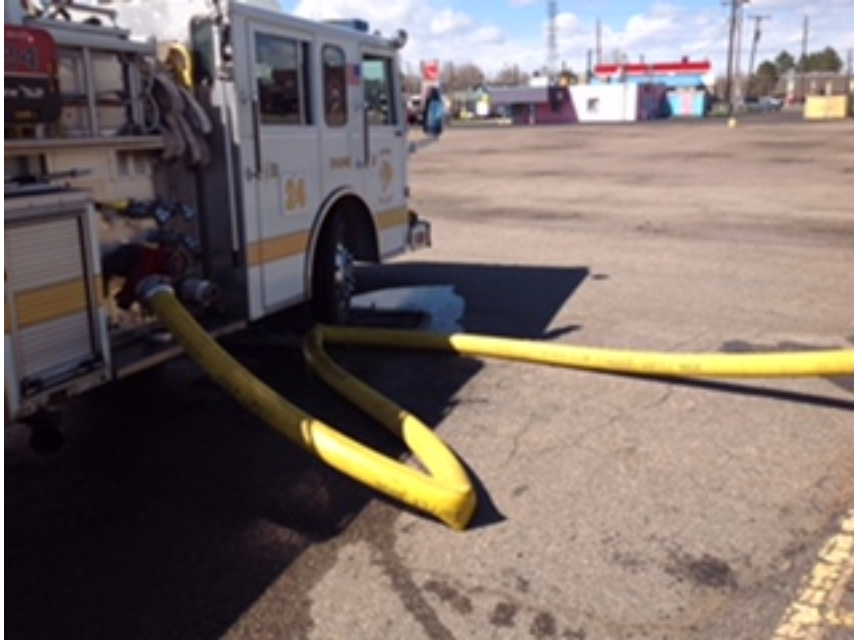
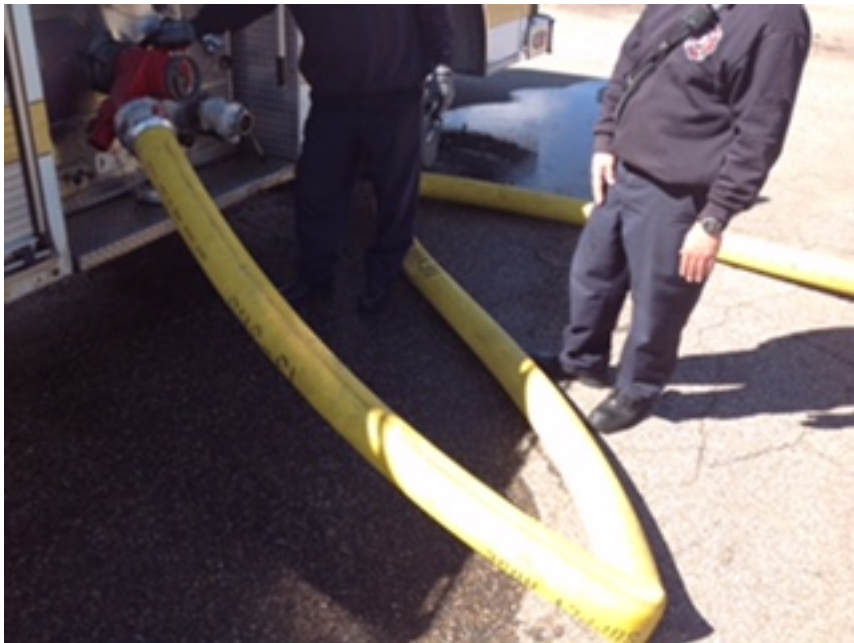
Engine 24's mission was to sustain the water supply to Engine 18, which was accomplished by completing the connection at the hydrant located at 9640 East Alameda Avenue, which consisted of two 3" lines, the Humat valve and the 35' LDH. The issue that occurred was unique and provides valuable feedback in regard to safety on scene. In normal situations, the engineer or acting engineer in this case, is often left to complete all requisite connections by themselves. This is due to the fact that rest of the crew normally engages in the firefighting operations. This was not the case. Engine 18 was operating their Deck Gun and the immediate need for an attack lines was not needed. The rest of the crew of Engine 24 stayed back to assist the acting engineer and this is where the safety issue occurred. The engineer was standing next to Engine 24 when the 35' LDH was charged by the junior firefighter. The resulting aggressive behavior of the 35' LDH, put the acting engineer in a poor protective position and the result was the acting engineer being trapped and thrown to the ground by the 35' LDH. The acting engineer was put off work Line of Duty for the remainder of the shift and treated for a sprained knee. He returned to full duty the following shift.

The following pictures were created with the help of Engine 24 and are not the actual layout from February 29, 2016. The recreation is intended for training purposes only in an effort to provide insight and educational information to the membership of the Denver Fire Department. If you have any questions regarding the above mentioned event, please call Lt. Dave Feilmeir.

1. Crew positioning. Maintain your situational awareness and where you position yourself during tactical operations. The acting engineer was positioned right at the intake valve and lost the protective position of being behind the hydrant, like he would during normal operations.
2. Minimize crew exposure during layouts of this nature. The crew, like any other crew, was trying to assist and support the operation by helping and expediting the layout process. By doing this, it put the crew in positions that would not normally occur. The officer stated he will insure that this won't happen again by going back to the basics and train.
3. Identify and define a safer layout process (see pictures). The crew worked with Safety and Training to recreate the incident and also identified safer ways to deploy the 35' LDH.
