FCM 071-2016

SUBJECT: ENGINE 9 NEAR MISS, INCIDENT 16-0030524

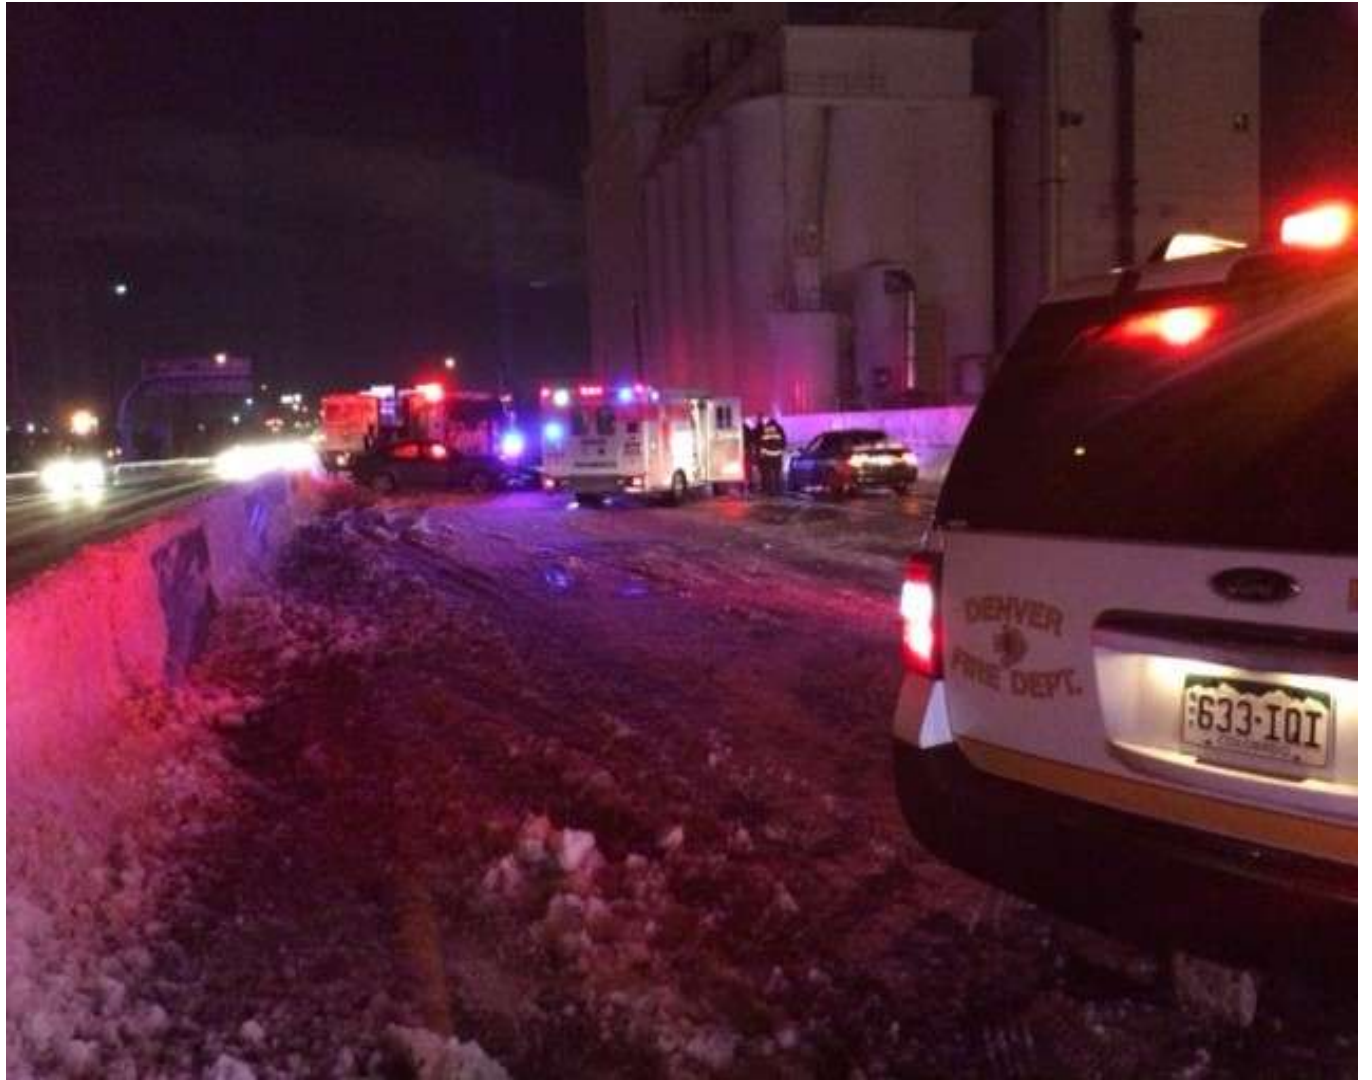
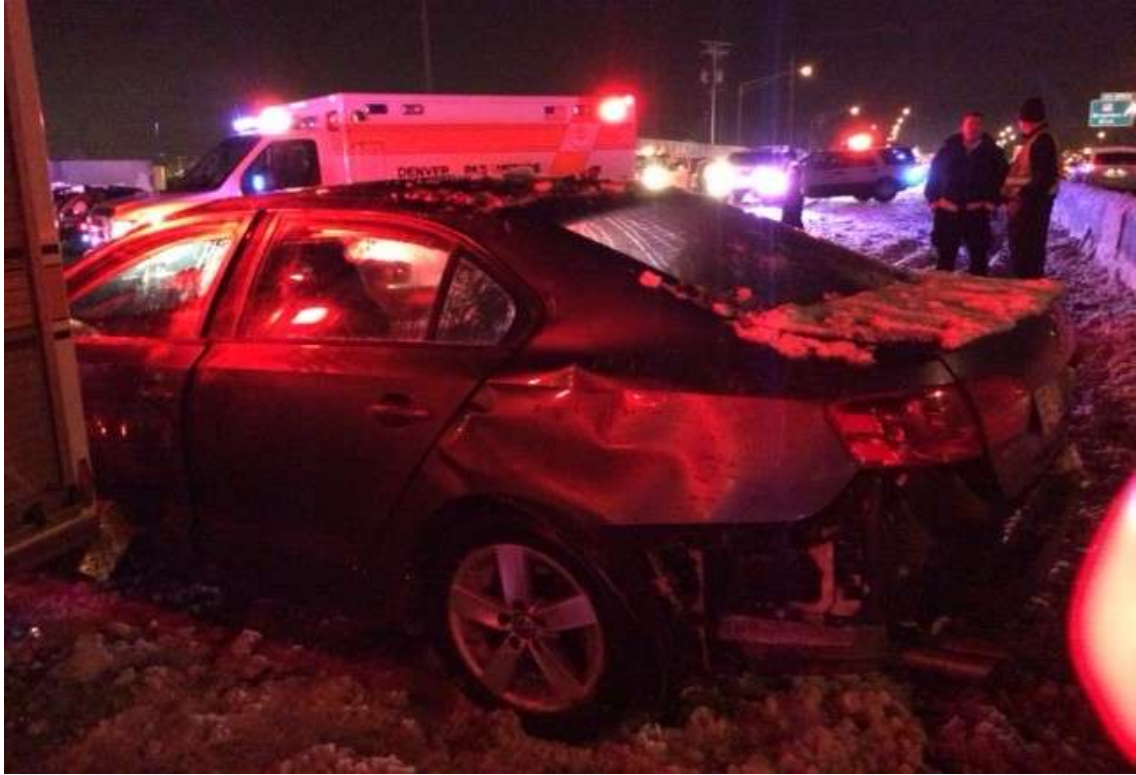
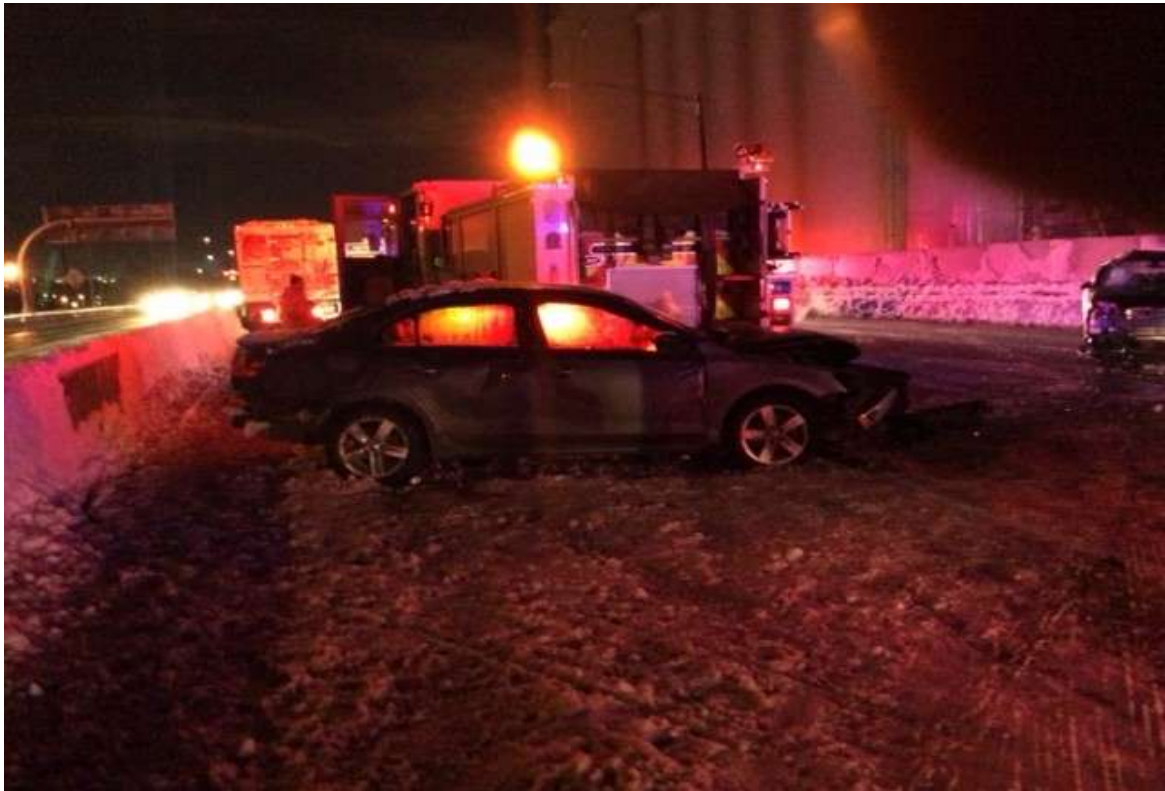
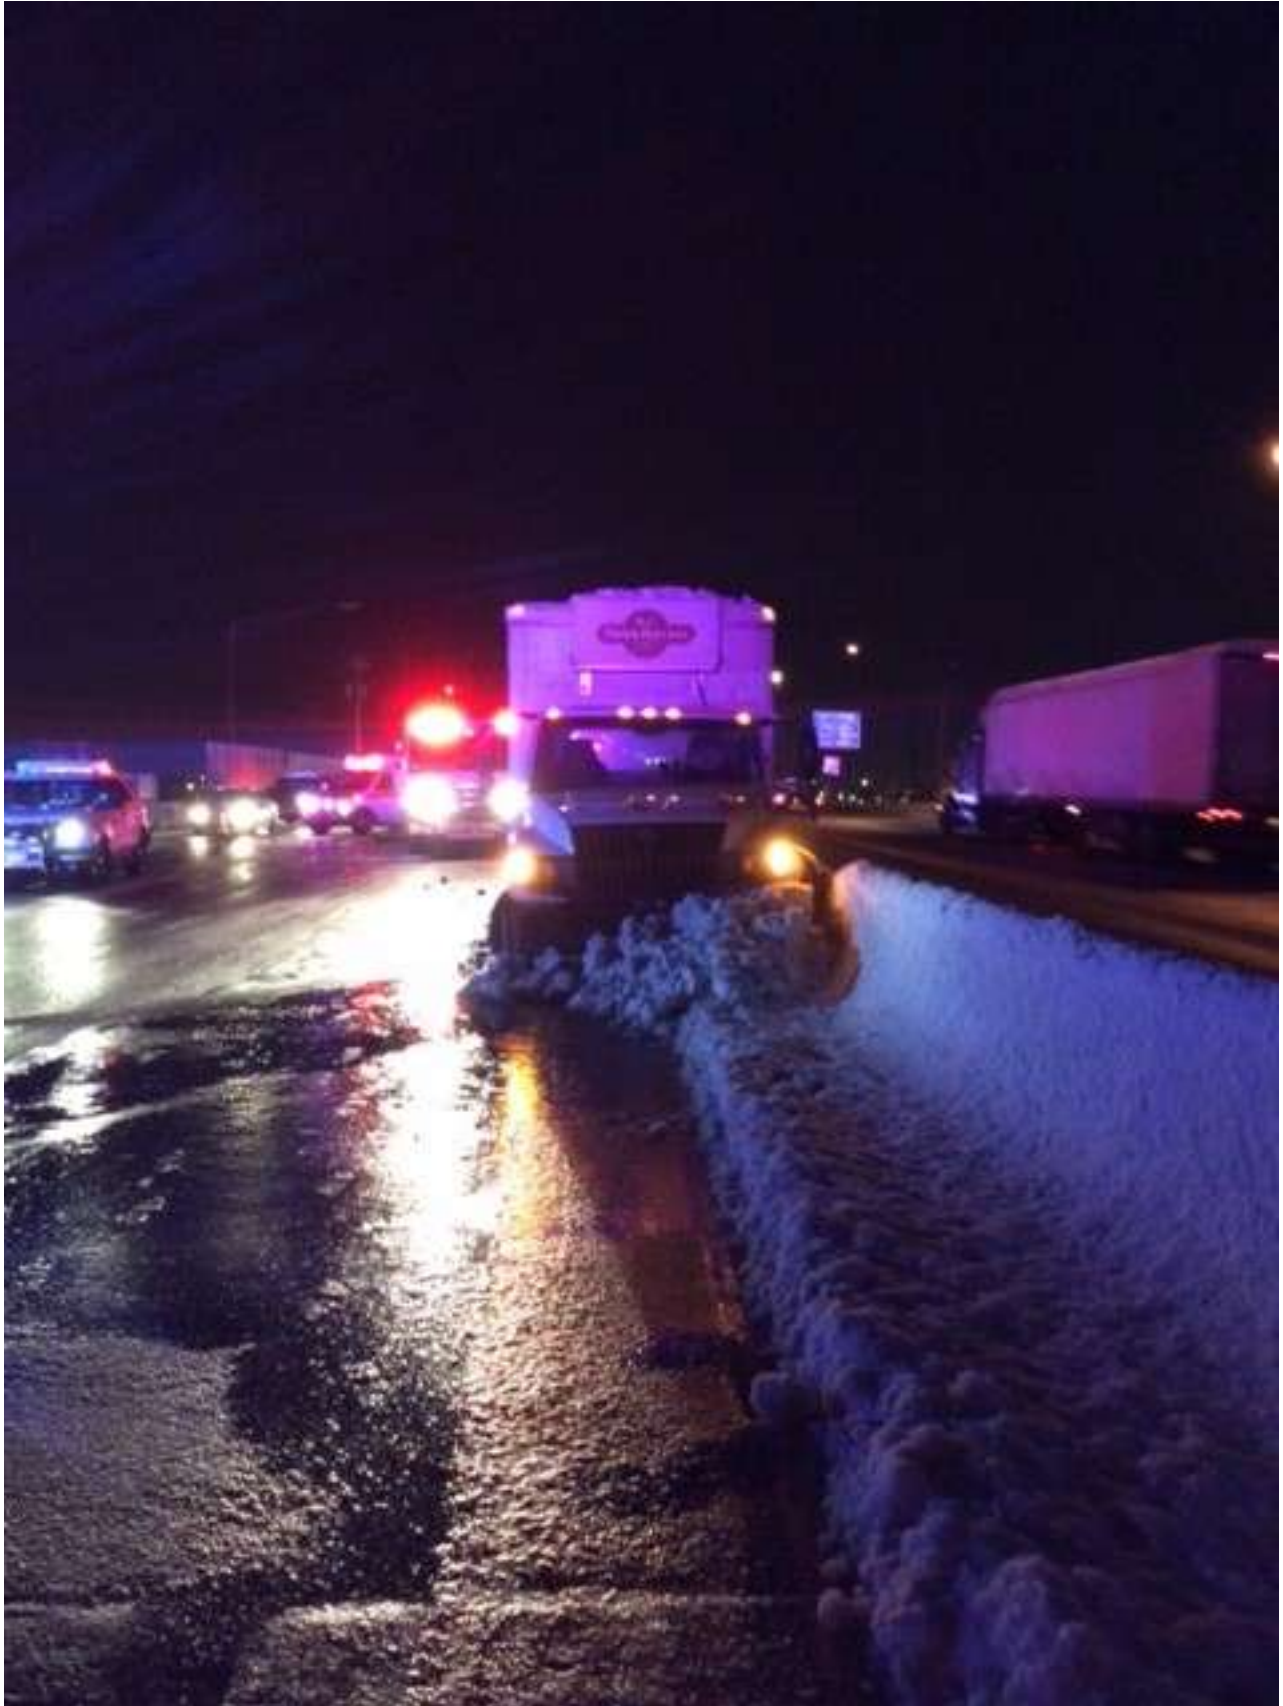
On March 23, 2016 at 21:12 hours, Engine 9 and Tower 9 were dispatched to an accident on eastbound I-70 and Brighton Boulevard. A vehicle was found by crews at I-70 and York Street, but it did not fit the description of the accident they were dispatched to. Tower 9 saw flashing lights further down the highway and proceeded to investigate while Engine 9 checked on the party at I-70 and York. While the crew of Engine 9 was waiting with one patient for police and paramedics, a car hit the back of Engine 9. Engine 9 requested assistance from Tower 9 and Chief 6 to protect the scene, and the crew from Engine 9 proceeded to check on the party that hit Engine 9. Tower 9 had been dispatched to yet another accident further down the highway, so Truck 26 was dispatched to assist Engine 9. Paramedics arrived and took a protective position behind Engine 9. Captain Miller stood in a position to watch traffic while his crew members were loading the patient on the pram when another vehicle slid to the left of the ambulance, bounced off the Jersey barrier, and struck Captain Miller and the rear of Engine 9.

The following pictures were from the accident, taken after Captain Miller was struck. This document is intended to provide insight into this accident and for members of the Denver Fire Department to review and discuss safety issues, not only on highway accidents but all traffic accidents.

1. When dispatched to highway accidents, both rigs dispatched should stay together.
2. Size the situation up and close lanes with apparatus to create a safe zone for members to operate. In this situation, lane 1 was left with enough space to allow a vehicle by.

5. Consideration should be given to close highways as needed when operating in these dangerous conditions.
6. In cases where a vehicle hits an apparatus protecting the scene, consideration should be given to make the scene safe again, whether that is by repositioning current apparatus, using other emergency vehicles on scene, and/or closing the highway.
