After Action Review: 3994 S. Syracuse Way

Date: 1/7/2017

Incident Number: 17-0002735

Address: 3994 S. Syracuse Way

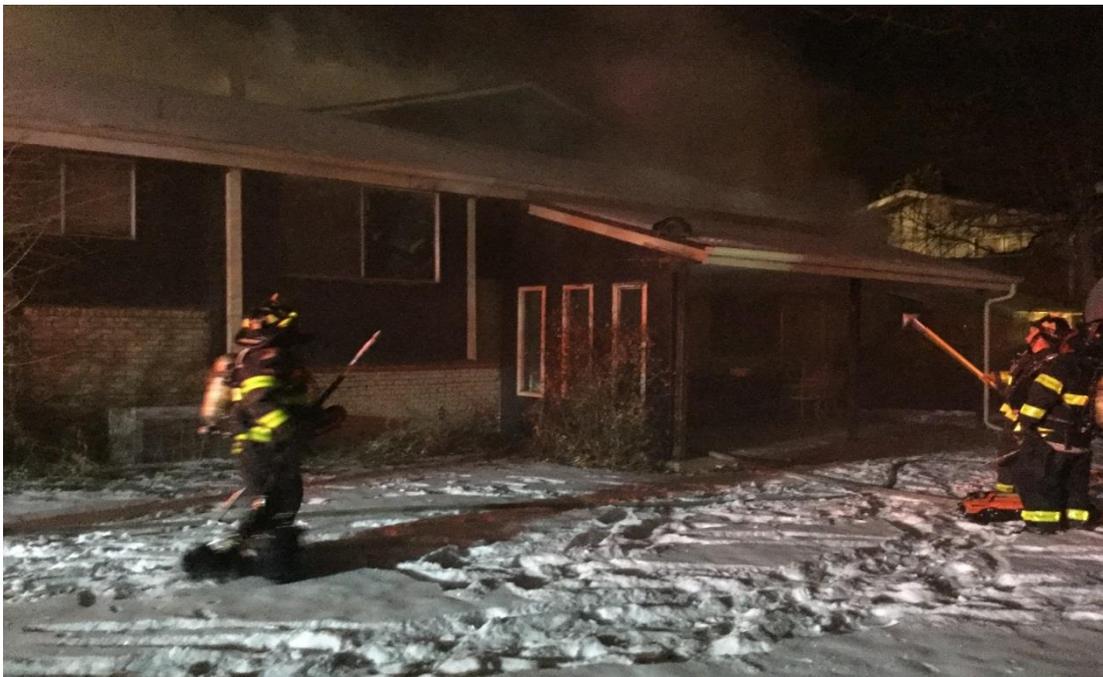
Companies responded to the initial calling address and had to transition to the location directly behind this residence. Tower 22 stayed at the original address until it was determined that there was no hazard at this location which caused them to go from the first Truck on scene to the last Truck thus becoming the RIT team. While the temptation to just cut and run may have been there for Tower 22 they were professional in how they addressed the situation. The Charlie and Delta team members of Truck 19 utilized their training and stayed clam when they felt their original means of egress was cut off. They stated that they knew they could shut the bedroom door and exit safely via a ladder. The call to ladder the second floor was the correct one and aided in turning this into a non-issue. Neighbors reported two occupants living there and an aggressive search was deployed. It was later discovered that the parties were not inside and possibly only used this structure for storage. The fire appeared to originate in the basement and extend to the upper floors through a chase. Crews did an excellent job of locating and extinguishing this fire. Protection of stair ways should always be a consideration and members following crews up stairways should position themselves so as to protect this means of egress. The fire was in a void space in the wall running from the basement to the second floor.
