## After Action Review: 4728 Vine St.

**Date:** 12/26/16      **Time:** 20:08      **Incident Number:** 16-0137862

**Address:** 4728 Vine St.

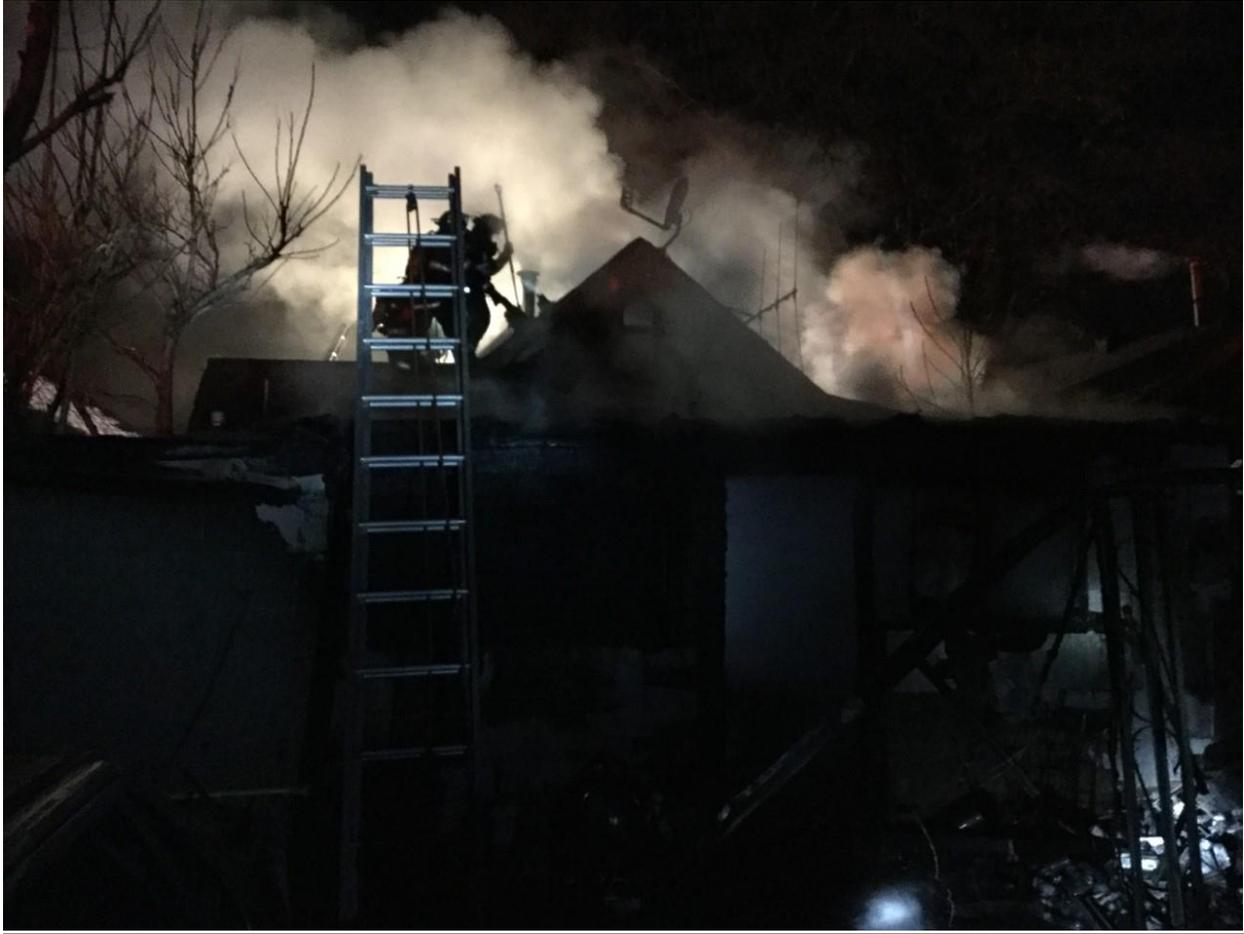
**Involvement Upon Arrival and Initial Location of Fire:** Heavy smoke showing on Alpha side, heavy fire that appeared to be exterior on Charlie side

**Special Challenges, Hazards, and Safety Issues:** Huge amount of conflicting information from incoming 911 calls (one large explosion, several small explosions, vehicles exploding, shots fired) all relayed to Companies enroute. Evidence on scene indicated that this fire was related to an illegal hash oil extraction operation (a large amount of small, consumer use sized butane cans on the exterior Charlie side). Other hazards included power lines down and spongy floors.
