After Action Review: 2187 S Depew St

Date: 1/31/17 **Time:** 06:31 **Incident Number:** 17-0011233

Address: 2187 S Depew St

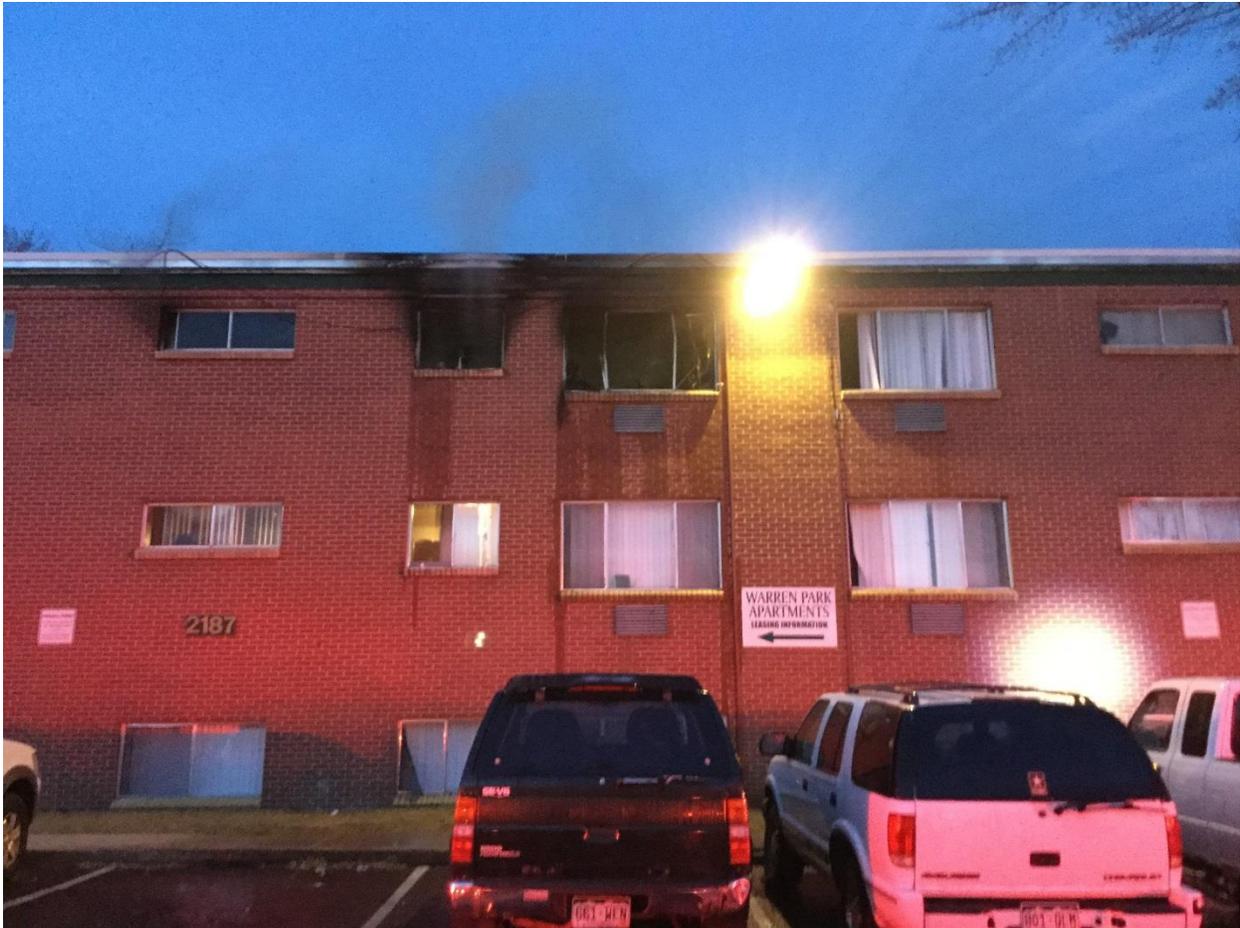
Risk vs Benefit: 3-story, brick veneer wood frame apartments (28 apartments in structure) with fire heavily involving one apartment but not weakening structural components at time of arrival, time of day (0630) indicating high likelihood of occupants, and phone call indicating parties trapped led to declaration of offensive interior attack.

Involvement Upon Arrival and Initial Location of Fire: One apartment, fire showing from window, top floor, middle of Alpha side
