## **After Action Review: 4631 N Josephine St**

**Date: 3/31/16      Time: 21:03:33      Incident Number:      16-0033472**

**Address: 4631 N Josephine St, Denver CO 80216**

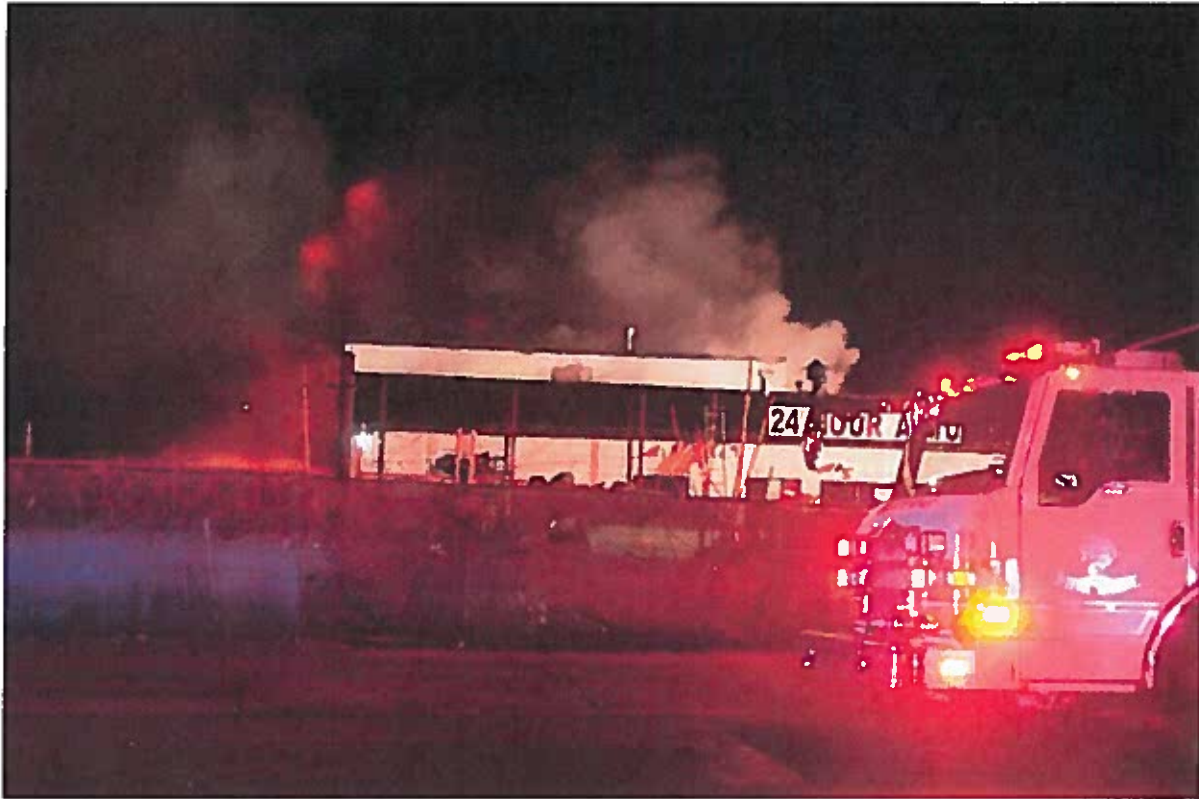
Heavy fire Charlie side exterior, extension into bldg.
