After Action Review: 1475 California Street

Date: 09/21/2016 **Time:** 11:38 **Incident Number:** 16-0101110

Address: 1475 California St

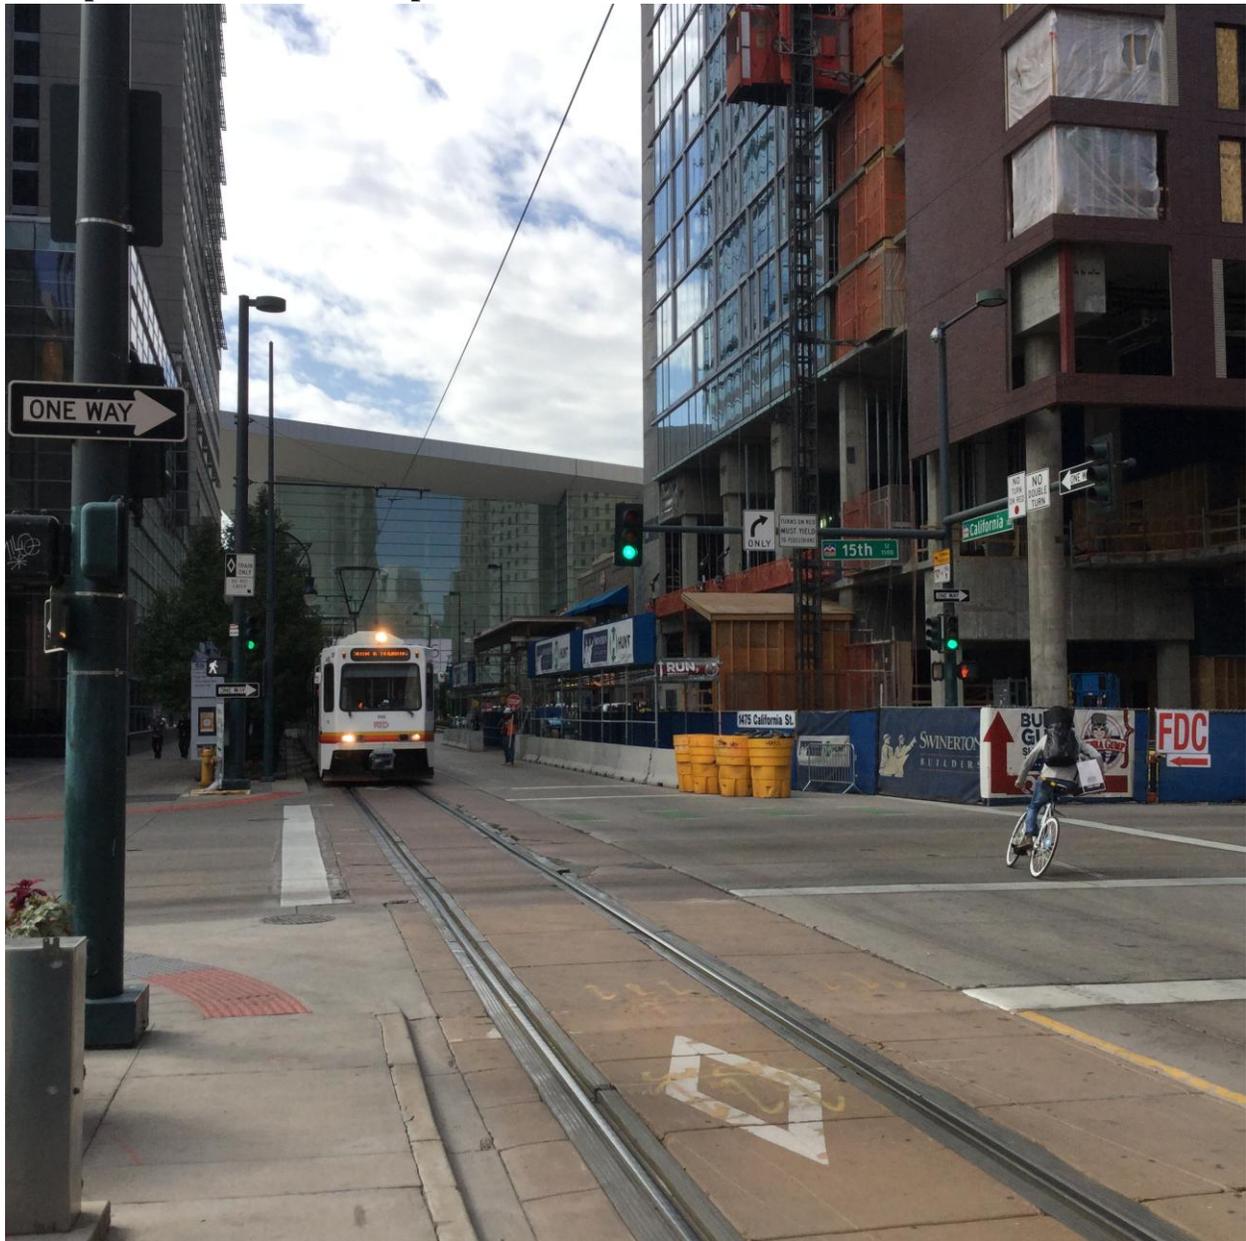
- Difficult apparatus placement Alpha side (street down to 1 lane due to 1 lane closed for construction, light rail stopped between apparatus, vehicles and bus stopped between apparatus). See picture at end of AAR.

Example of street width on Alpha side:

- Continue to address different types of outside hazards at incidents. In this case, RTD had to shut down light rail tracks. A light rail train was unmovable right in front of the address for the entire suppression portion of the incident. This hazard was addressed quickly and is a good example of the range of different obstacles encountered at an incident.
