## **After Action Review: 1208 S. Mariposa St.**

**Date: 3/19/16      Time: 0937      Incident Number: 16-0028626**

**Address: 1208 S Mariposa, Denver CO 80223**

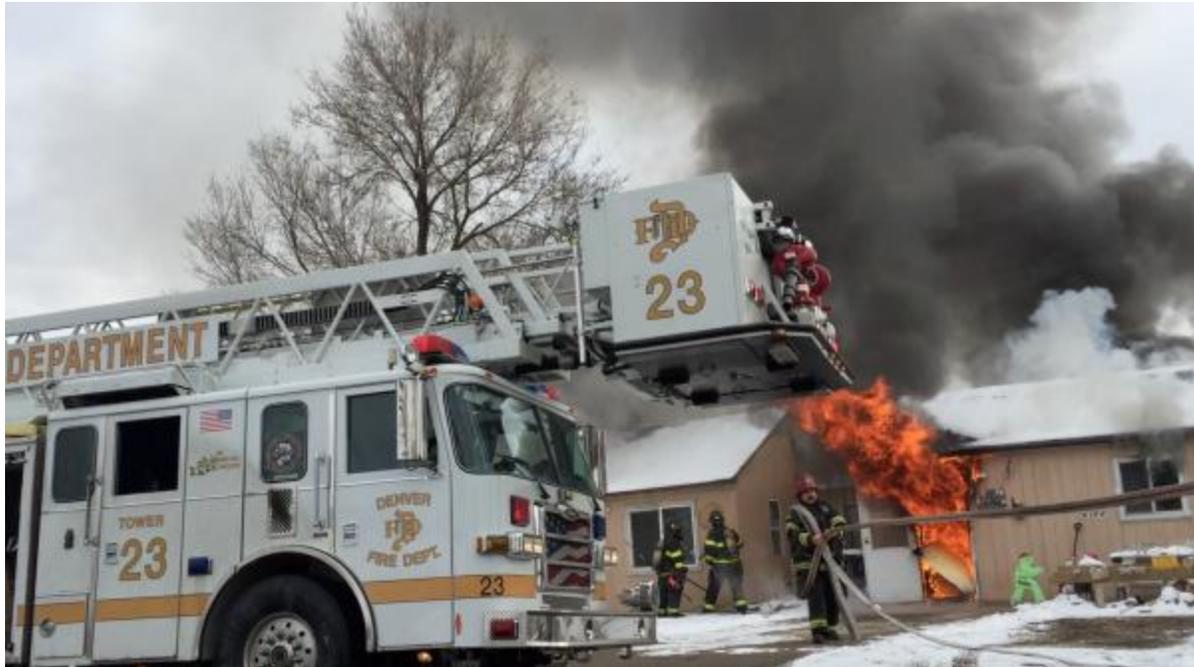
**Summary- Companies that responded to this fire encountered a highly modified structure with interior hoarding conditions. Heavy smoke and fire were present on arrival and numerous hazards developed during extinguishment. Four hand lines were used to control fire as well as 3 extra apparatus (HAMER 1, Truck 12, and Engine 5). The IC was able to manage this incident effectively by using single resources. 2 firefighters received slight burns to the neck/ears and were treated on scene by DHMC, their turnout gear and SCBA's sustained heat damage and were pulled out of service to be inspected. Fire cause is under investigation. The positive actions of the DFD enabled this difficult fire to be placed under control in approximately 30 minutes.**
