DFD INTERNAL CORRESPONDENCE

DATE: March 25, 2016
TO: All DFD Personnel
THROUGH: Charles Drennan III, Operations Division Chief
FROM: C.J. Haberkorn, Shift Commander, Operations
SUBJECT: **AFTER ACTION REVIEW-Engine 24 FF INJURY, Incident 16-21551**

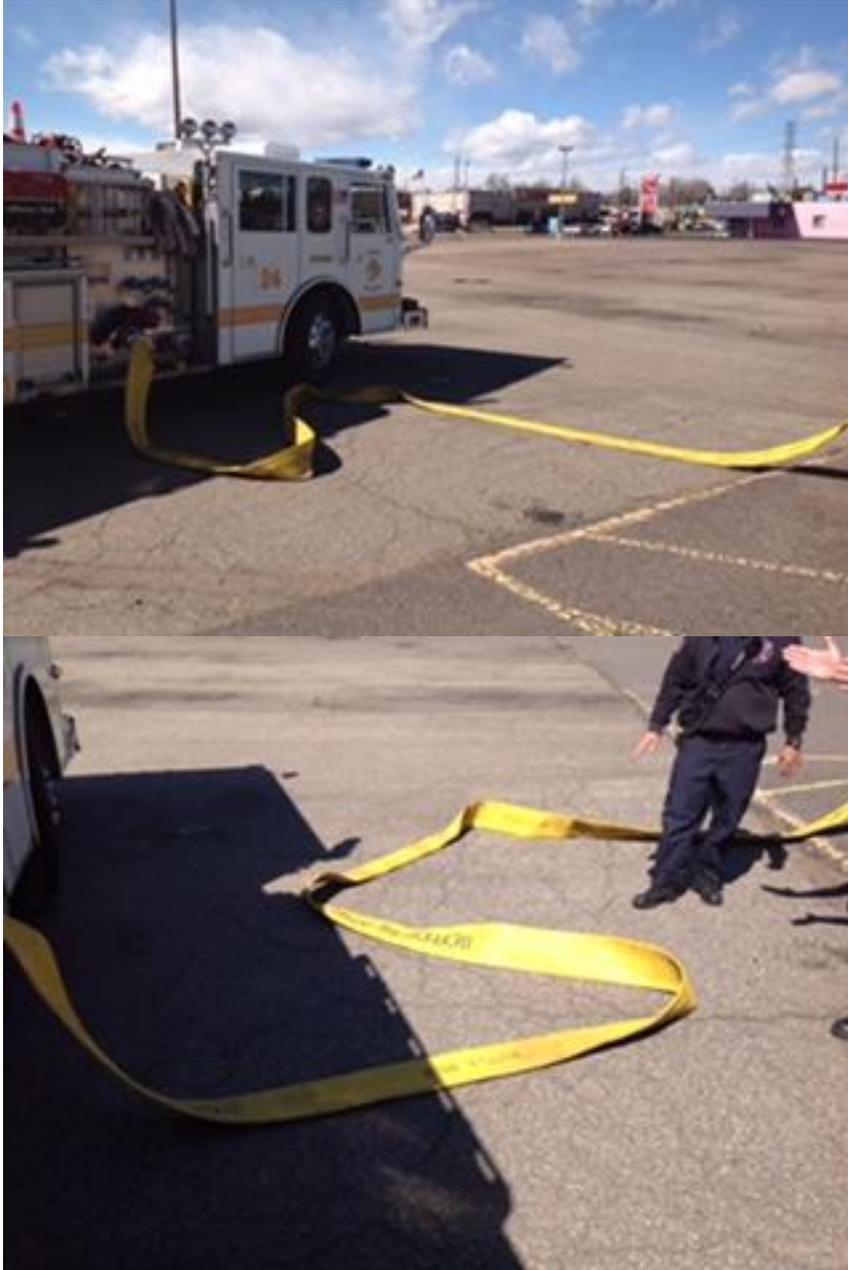
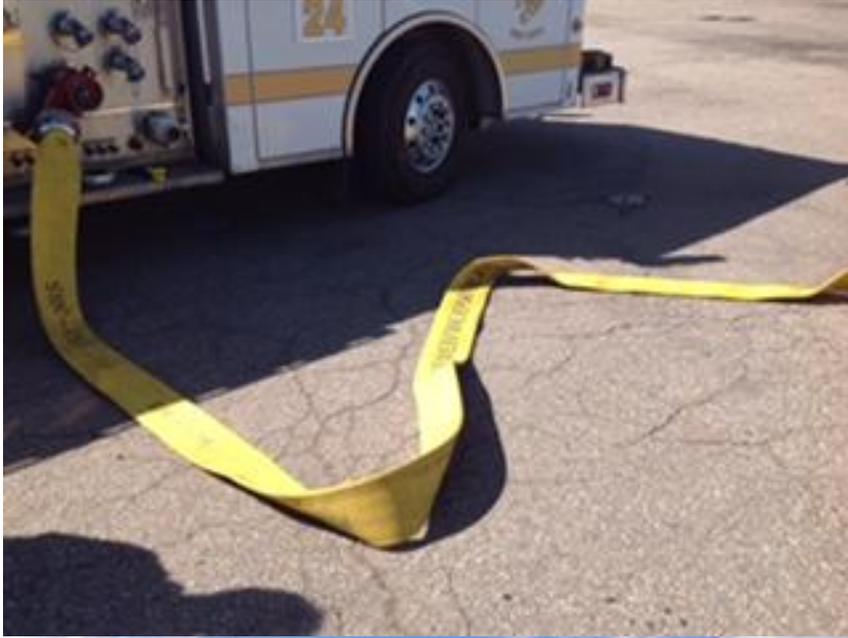
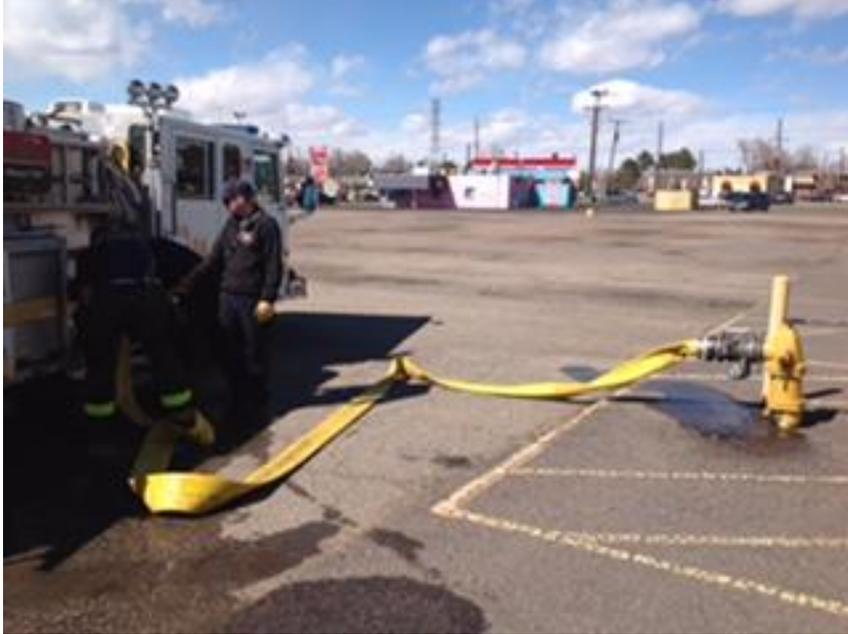
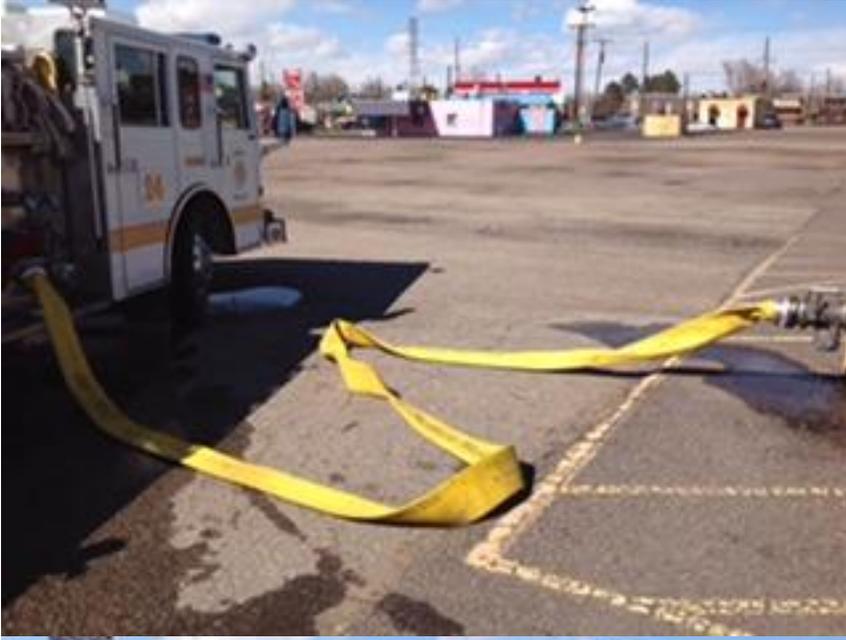
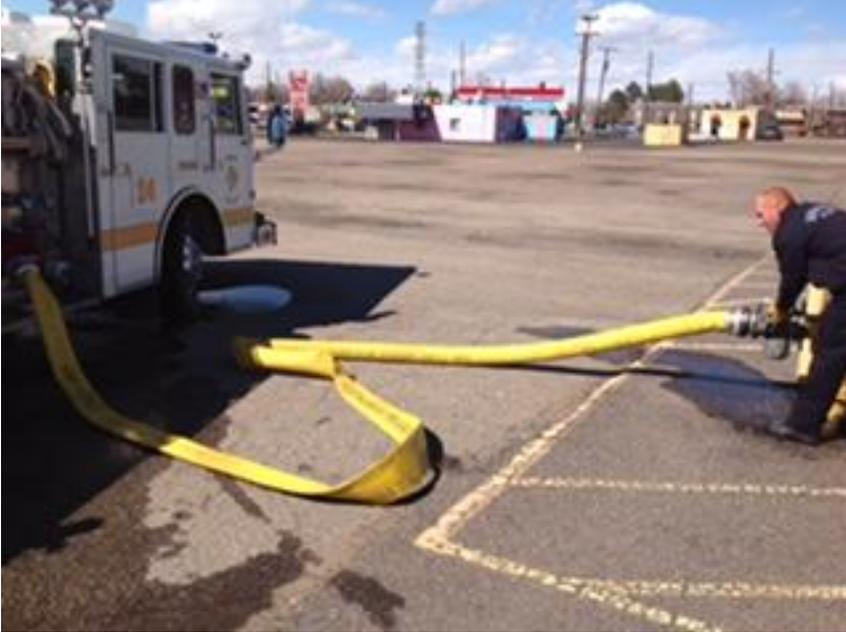
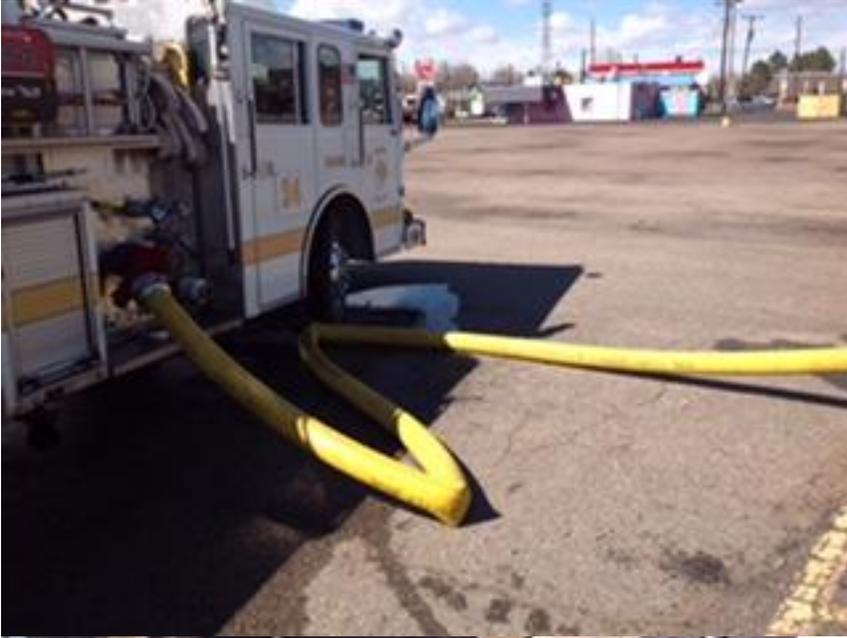
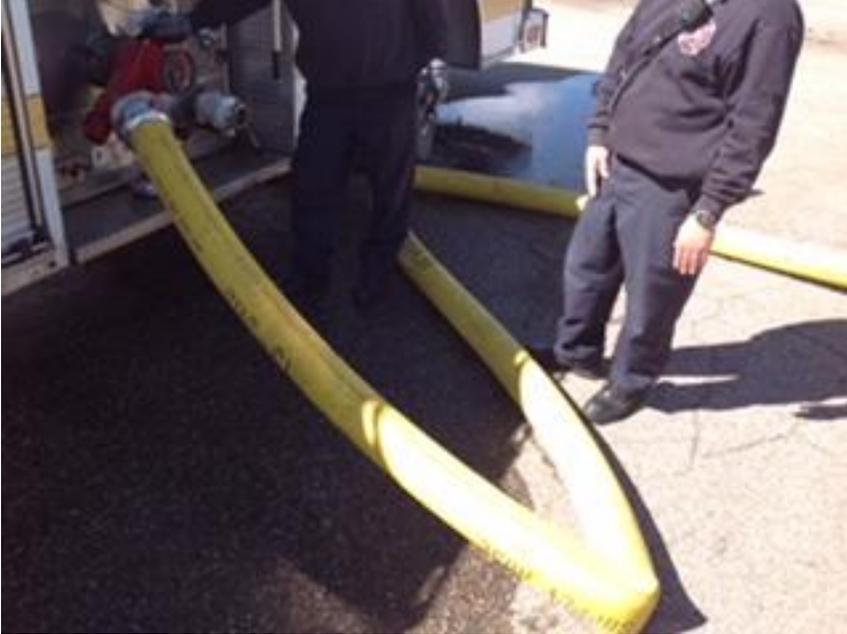
operations. This was not the case. Engine 18 was operating their Deck Gun and the immediate need for an attack lines was not needed. The rest of the crew of Engine 24 stayed back to assist the acting engineer and this is where the safety issue occurred. The engineer was standing next to Engine 24 when the 35' LDH was charged by the junior firefighter. The resulting aggressive behavior of the 35' LDH, put the acting engineer in a poor protective position and the result was the acting engineer being trapped and thrown to the ground by the 35' LDH. The acting engineer was put off work Line of Duty for the remainder of the shift and treated for a sprained knee. He returned to full duty the following shift.

The following pictures were created with the help of Engine 24 and are not the actual layout from February 29, 2016. The recreation is intended for training purposes only in an effort to provide insight and educational information to the membership of the Denver Fire Department. If you have any questions regarding the above mentioned event, please call Lt. Dave Feilmeir.

1. Crew positioning. Maintain your situational awareness and where you position yourself during tactical operations. The acting engineer was positioned right at the intake valve and lost the protective position of being behind the hydrant, like he would during normal operations.
2. Minimize crew exposure during layouts of this nature. The crew, like any other crew, was trying to assist and support the operation by helping and expediting the layout process. By doing this, it put the crew in positions that would not normally occur. The officer stated he will insure that this won't happen again by going back to the basics and train.
3. Identify and define a safer layout process (see pictures). The crew worked with Safety and Training to recreate the incident and also identified safer ways to deploy the 35' LDH.
