After Action Review: 2641 So. Cherokee Street

Date: 11/13/2018 Time: 0143 Incident Number: 18-123280

Address: 2641 So. Cherokee Street

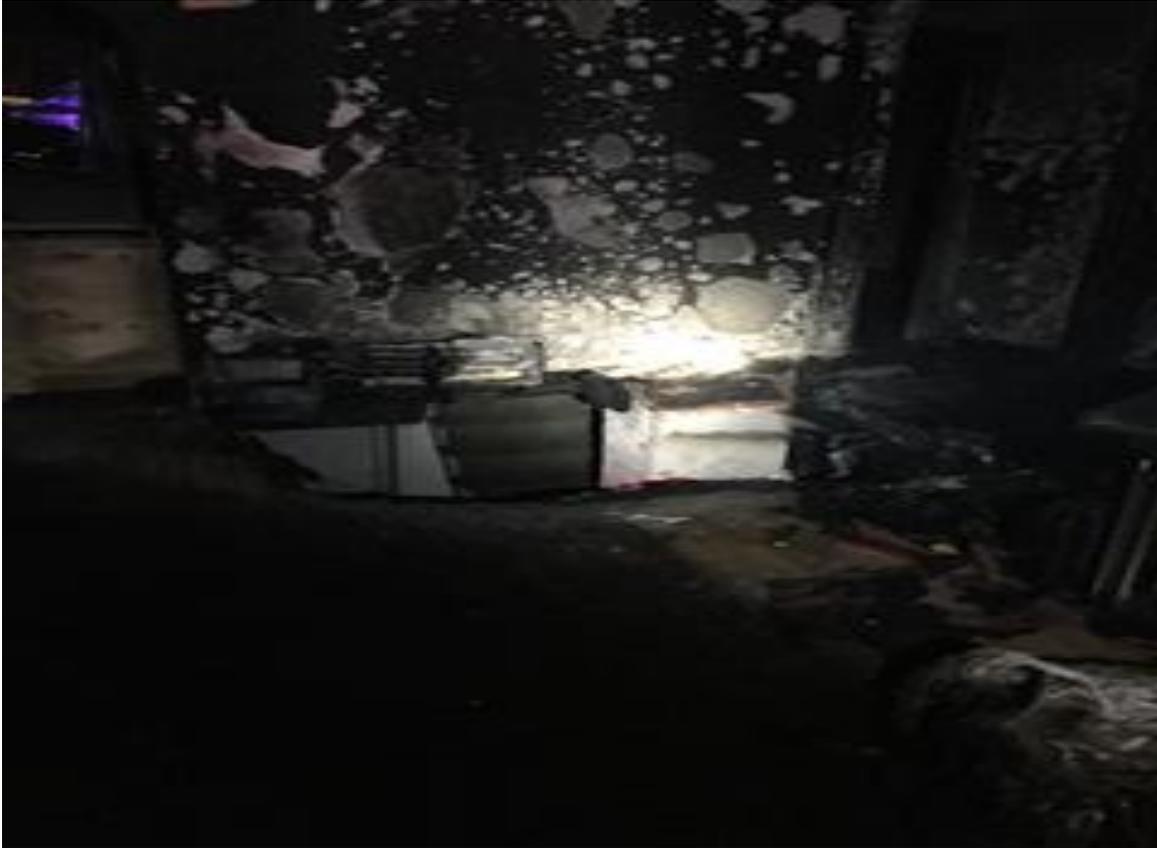
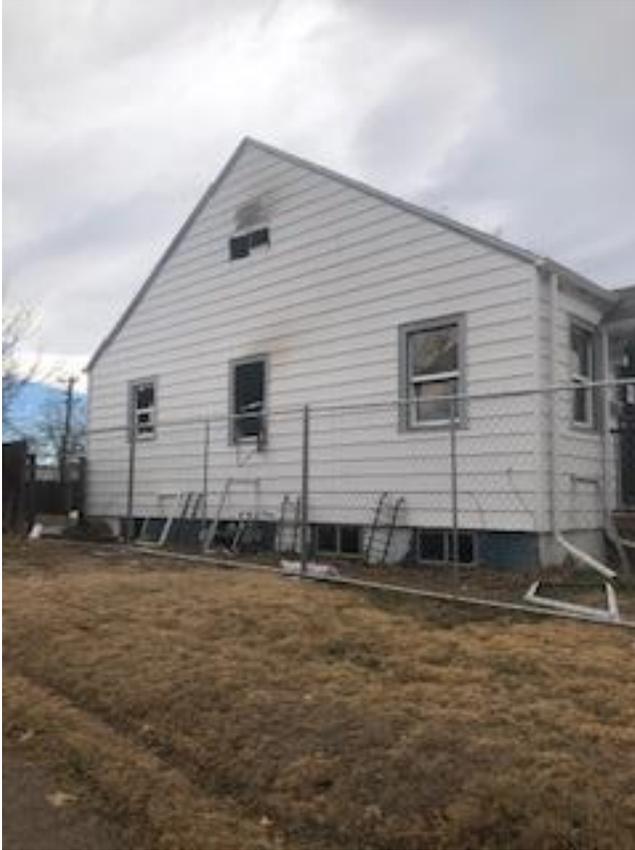
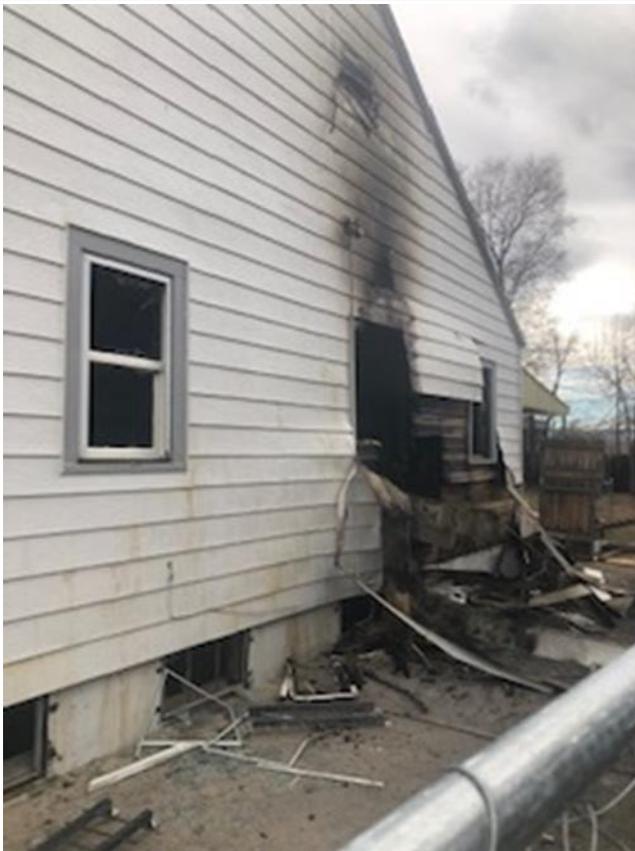
- Identification of the burned-out floor by E37 was communicated quickly. However, once the smoke lifted, this hazard proved much grander than what was initially communicated. (see pics)

- Following an aggressive overhaul of the Delta-side, it was determined that the fire had completely burned out the interior framing where most of the fire was. This validated the aggressive opening-up of the exterior walls and exterior attack initiated by D03.
