After Action Review: 9260 East Mansfield

Date: 3/21/2020 Time: 1334 Incident Number: 20-30236

Address: 9260 E Mansfield

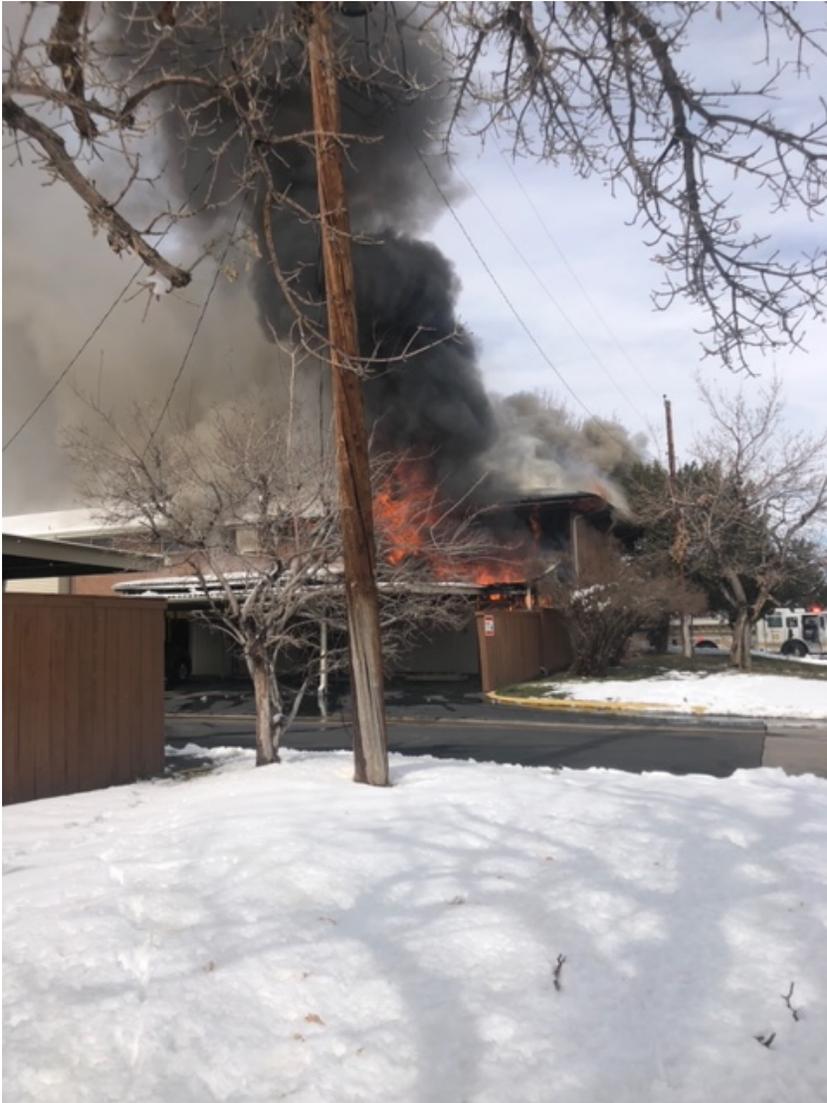
E-13 just arriving on scene, view from the Charlie side

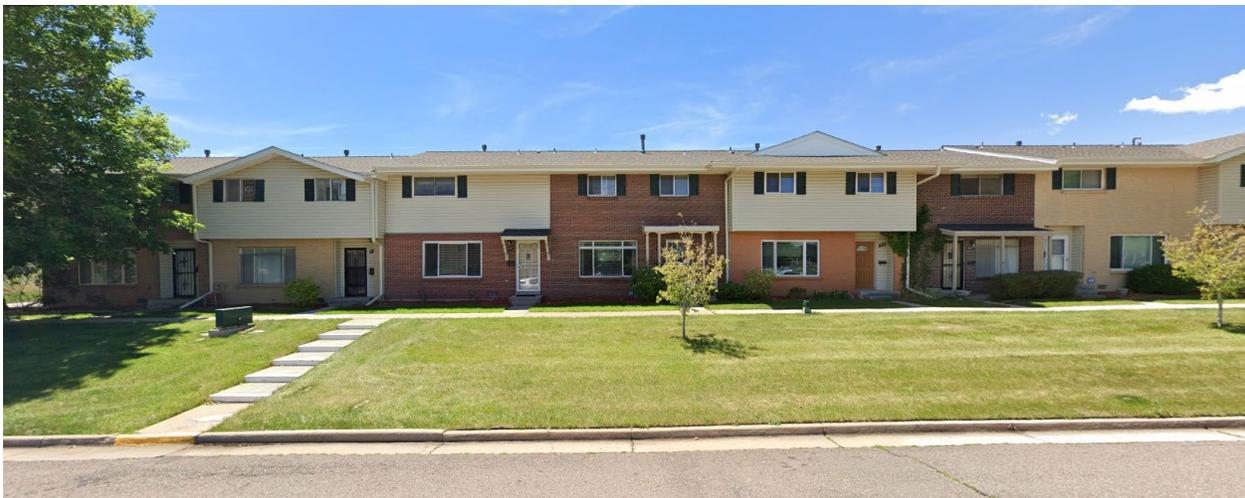
ALPH SIDE

The first unit to the east on the A/B corner is the original fire unit.
