## **After Action Review: 965 Pennsylvania**

**Date:** March 30, 2016      **Time:** 2152      **Incident Number:** 16-33168

**Address:** 965 Pennsylvania

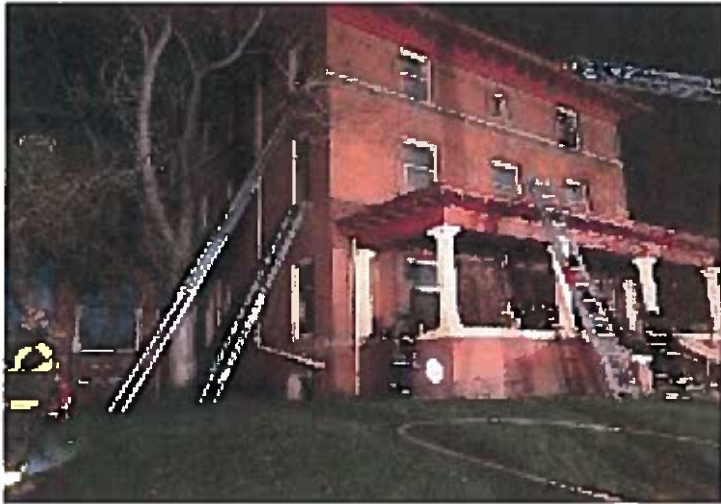
**Event Description:** On March 30, 2016 at 2152 hrs. Denver Fire responded to the address of 965 Pennsylvania for a reported structure fire. Upon arrival, Rescue One assumed command and reported a large volume of smoke and fire showing from the first floor, Bravo side of a two-story converted mansion. Engine 8 secured a water supply and laid to the front of the building. Engine 8 was the primary attack line and rapidly deployed an attack line through the Alpha side of the building and began attacking the fire from the unburned side. Engine 11 secured a second water supply as was ordered to the Charlie Division, while Engine 1 was assigned as back-up to Engine 8. Chief 2 arrived on scene and assumed command from Rescue One and assigned Rescue One to a primary search of the first floor. Truck 8 was assigned to the second floor to do a primary search, found a victim and extricated the victim out of the Alpha side to awaiting Denver Health Paramedics. Truck 4 was assigned to roof operations and gave a report of no extension or exposure. Tower 1 was ordered to "empty their beds" and ladder all sides of the building. Finally, Tower 15 was assigned as the RIT and proceeded to remove 12 sets of bars on windows and a few pieces of plywood during the RIT RECON.

The fire was rapidly brought under control and the fire was confined to the first floor, on the Bravo Side in the area of origin.

**Involvement Upon Arrival:** Sunroom, Bravo Side, Fully Involved, smoke on three floors.

- 12 sets of bars on windows and plywood covered windows.
- Multiple occupants in building
- Possible collapse hazard identified and addressed by Safety Officer of the fire damaged sunroom. Problem was evaluated and addressed and deemed non-hazardous.
