Date: 1/21/2018 Time: 19:34 Incident Number: 18-007848

Address: 4672 N. Eureka Ct.

Overview:

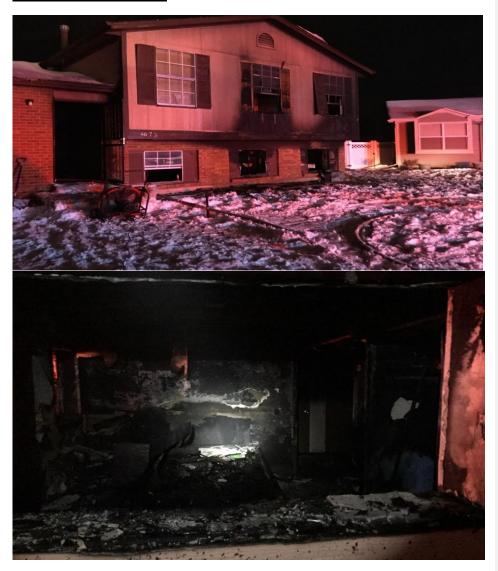
Alpha/Delta room, picture taken from the Delta window
